NOTE / TECHNICAL REPORT

Sedimentation analysis at the mouth of the Dique Channel to the Cartagena Bay through hydrographic surveys

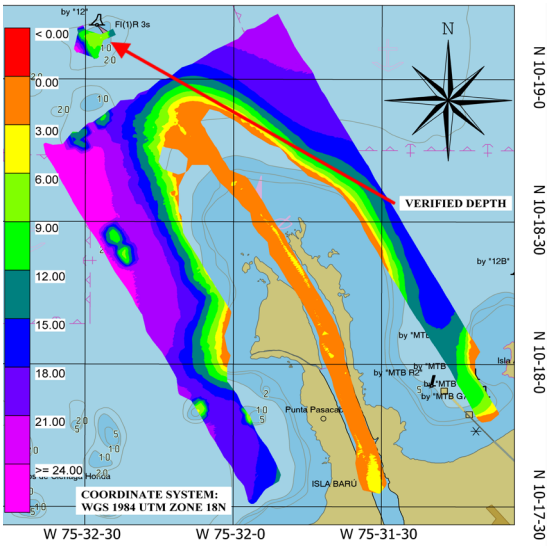
During this study, a depth of 1.2 m was verified and plotted on ENC CO500261, near buoy No. 18 of the navigable channel of Cartagena Bay, located in front of the mouth of the Dique Channel. When carrying out hydrographic search lines on the shallows, it was determined that this depth did not correspond to current conditions, since depths of 7 m were previously recorded in the area (Fig. 4).

Fig. 4 Coverage area of 2023 survey and depth verification.

This information is of great importance for the update the ENC CO500261 "Cartagena Bay".

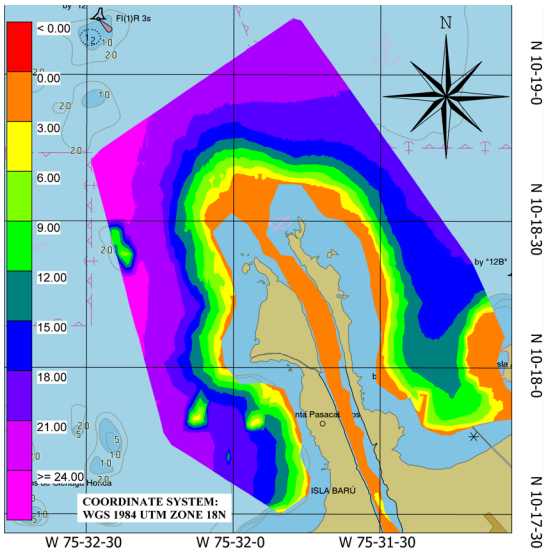
Fig. 5 Hydrographic survey of 2012.

The analysis of the information was conducted using the data collected in the year 2023 (Fig. 7), which were compared with the most recent studies of the same area. This information is stored in the hydrographic database of the Caribbean Center for Oceanographic and Hydrographic Research and corresponds to surveys conducted in the years 2012 and 2020 (Figs. 5 and 6).

Between the hydrographic surveys of the years 2012 and 2020, it was observed that the 4-meter depth contour in the Bay of Cartagena shifted 420 m towards the 324° mark. Depths that were previously 21 m deep now measure 4 m. Similarly, between the surveys of the years 2020 and 2023, the 4-meter contour moved 200 m towards the inner part of the Bay of Cartagena at the 327° mark, leaving it only 800 m away from the navigable channel.

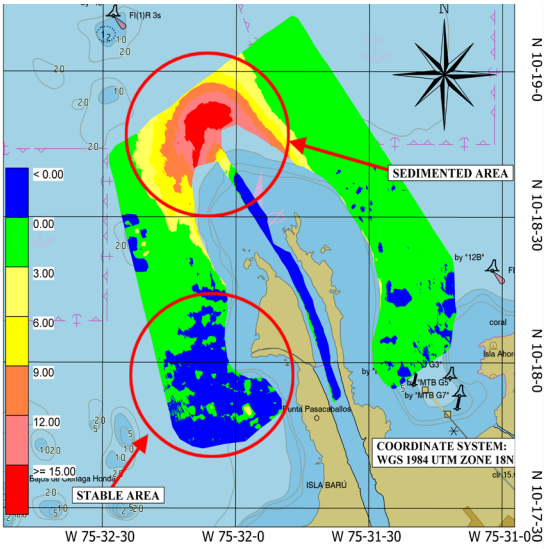
In Fig. 8, the areas of higher sedimentation in the sector over an 8-year period (2012–2020) are observed. The blue colors represent areas where depths have not undergone significant changes, while the red colors correspond to zones that have experienced greater changes due to sedimentation. Similarly, in Fig. 9, differences over a 3-year period (2020–2023) are depicted. By maintaining the same color scale, stable areas and sediment-affected zones can be clearly identified.

Fig. 8 Difference in depths between surveys from 2012–2020.

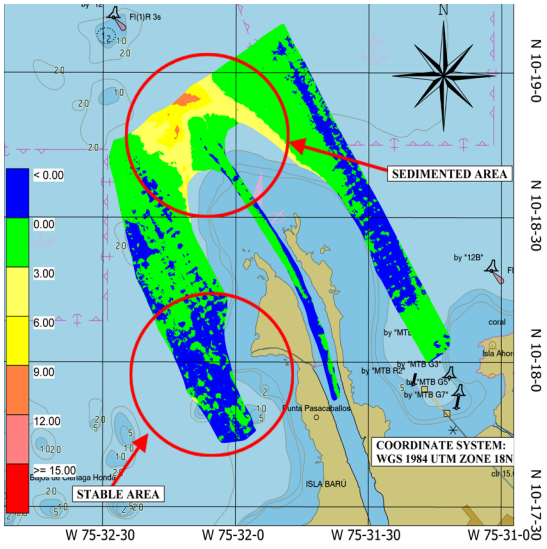
Fig. 9 Difference in depths between surveys from 2020–2023.

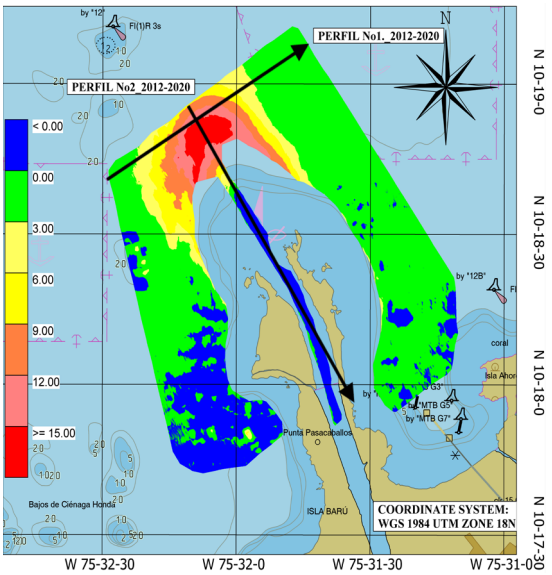
Fig. 10 Verification profiles between surveys 2012–2020.

Longitudinal and transverse profiles were also conducted throughout the entire study area to perform depth comparison analyses among the different surveys (Figs. 10 and 13). This approach was undertaken to validate the significant changes in the seafloor geomorphology caused by sediment deposition resulting from the Dique Channel 's influence on the Bay of Cartagena over time.

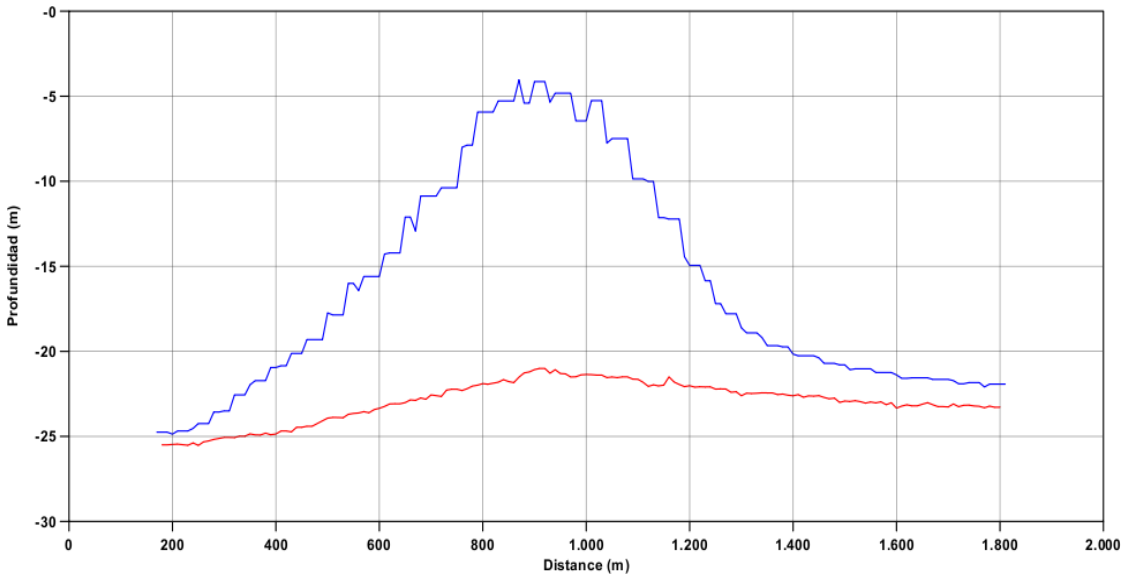
In Figs. 11 and 12, the comparison of profiles between the surveys conducted in the years 2012 and 2020 can be observed. The red line represents the year 2012, while the blue line represents the survey conducted in the year 2020. Similarly, in Figs. 14 and 15, the respective profile comparisons between the hydrographic surveys of the years 2020 and 2023 are evident.

Fig. 11 Profile No. 1 between surveys 2012 (red) – 2020 (blue).

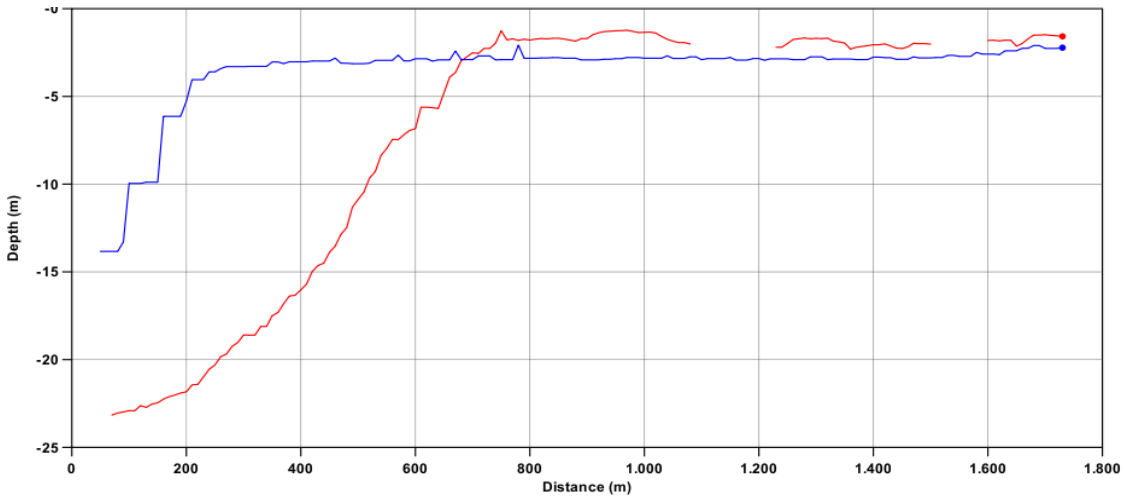
Fig. 12 Profile No. 2 between surveys 2012–2020.

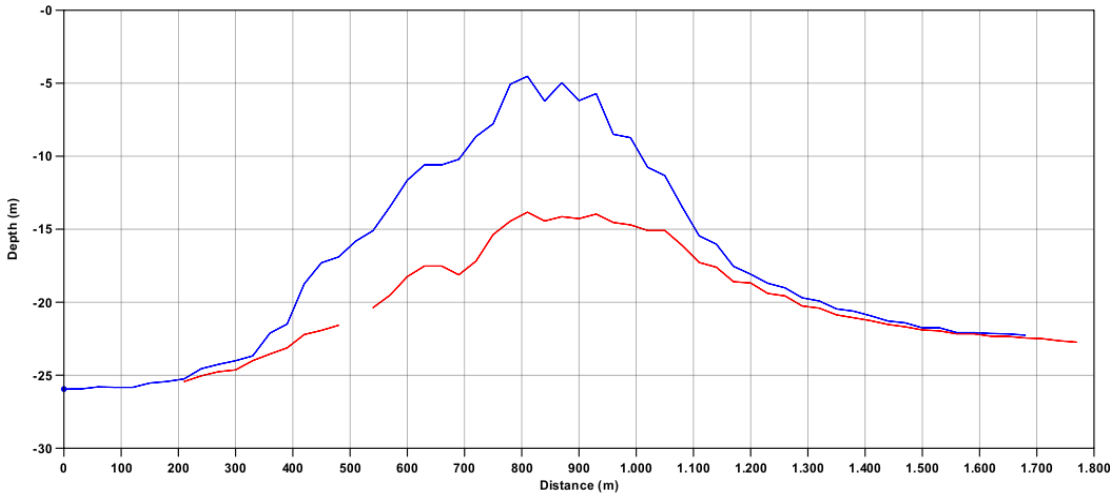
Fig. 14 Profile No. 1 between surveys 2020–2023.

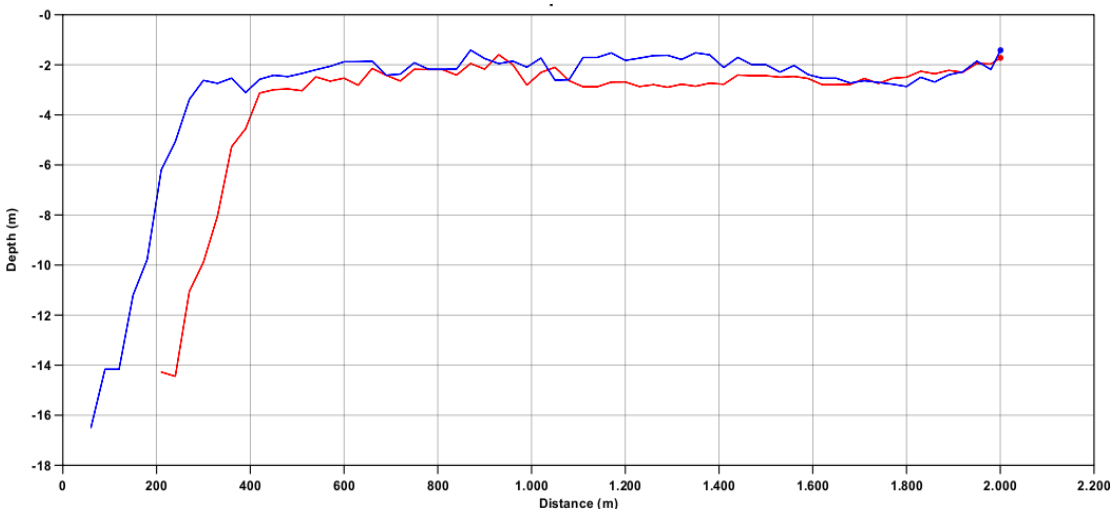
Fig. 15 Profile No. 2 between surveys 2020–2023.

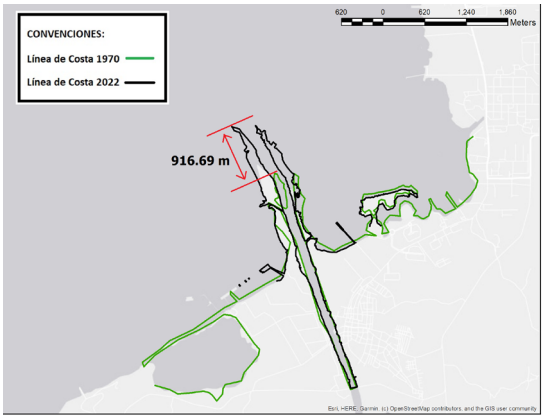
Using the multiyear shorelines, an analysis of the evolution of the coastal edge was performed, revealing that the shoreline has moved longitudinally 916.69 m towards the Bay of Cartagena between 1970 (green line) and 2022 (black line), evidencing the high sedimentation in this 52-year period. See Fig. 17 for reference.

The coastline at the mouth of the Dique Channel has longitudinally shifted 916.69 m towards the Bay of Cartagena over a span of 52 years. See Fig. 17 for reference.

The displacement of the coastline is due to the sediments brought by the Dique Channel, causing erosion at its mouth in the same direction.

Fig. 17 Coastline comparison between the years 1970 and 2022.

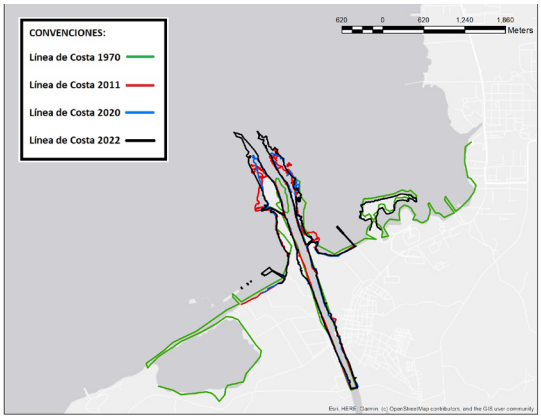
Fig. 16 Coastlines in the Dique Channel.

Using the Google Earth tool, the digitization of the coastlines at the mouth of the Dique Channel for the years 1970, 2011, 2020, and 2022 was carried out. These data were exported in *.kmz format and converted to *.shp using ESRI's Geographic Information System software (ArcGIS), as shown in Fig. 16.
